CASE PACIFIC TAKES ON PITKINS CURVE:

Repairing Scenic California Highway After a Landslide

By Will Gehrke, Case Pacific, Paso Robles, California

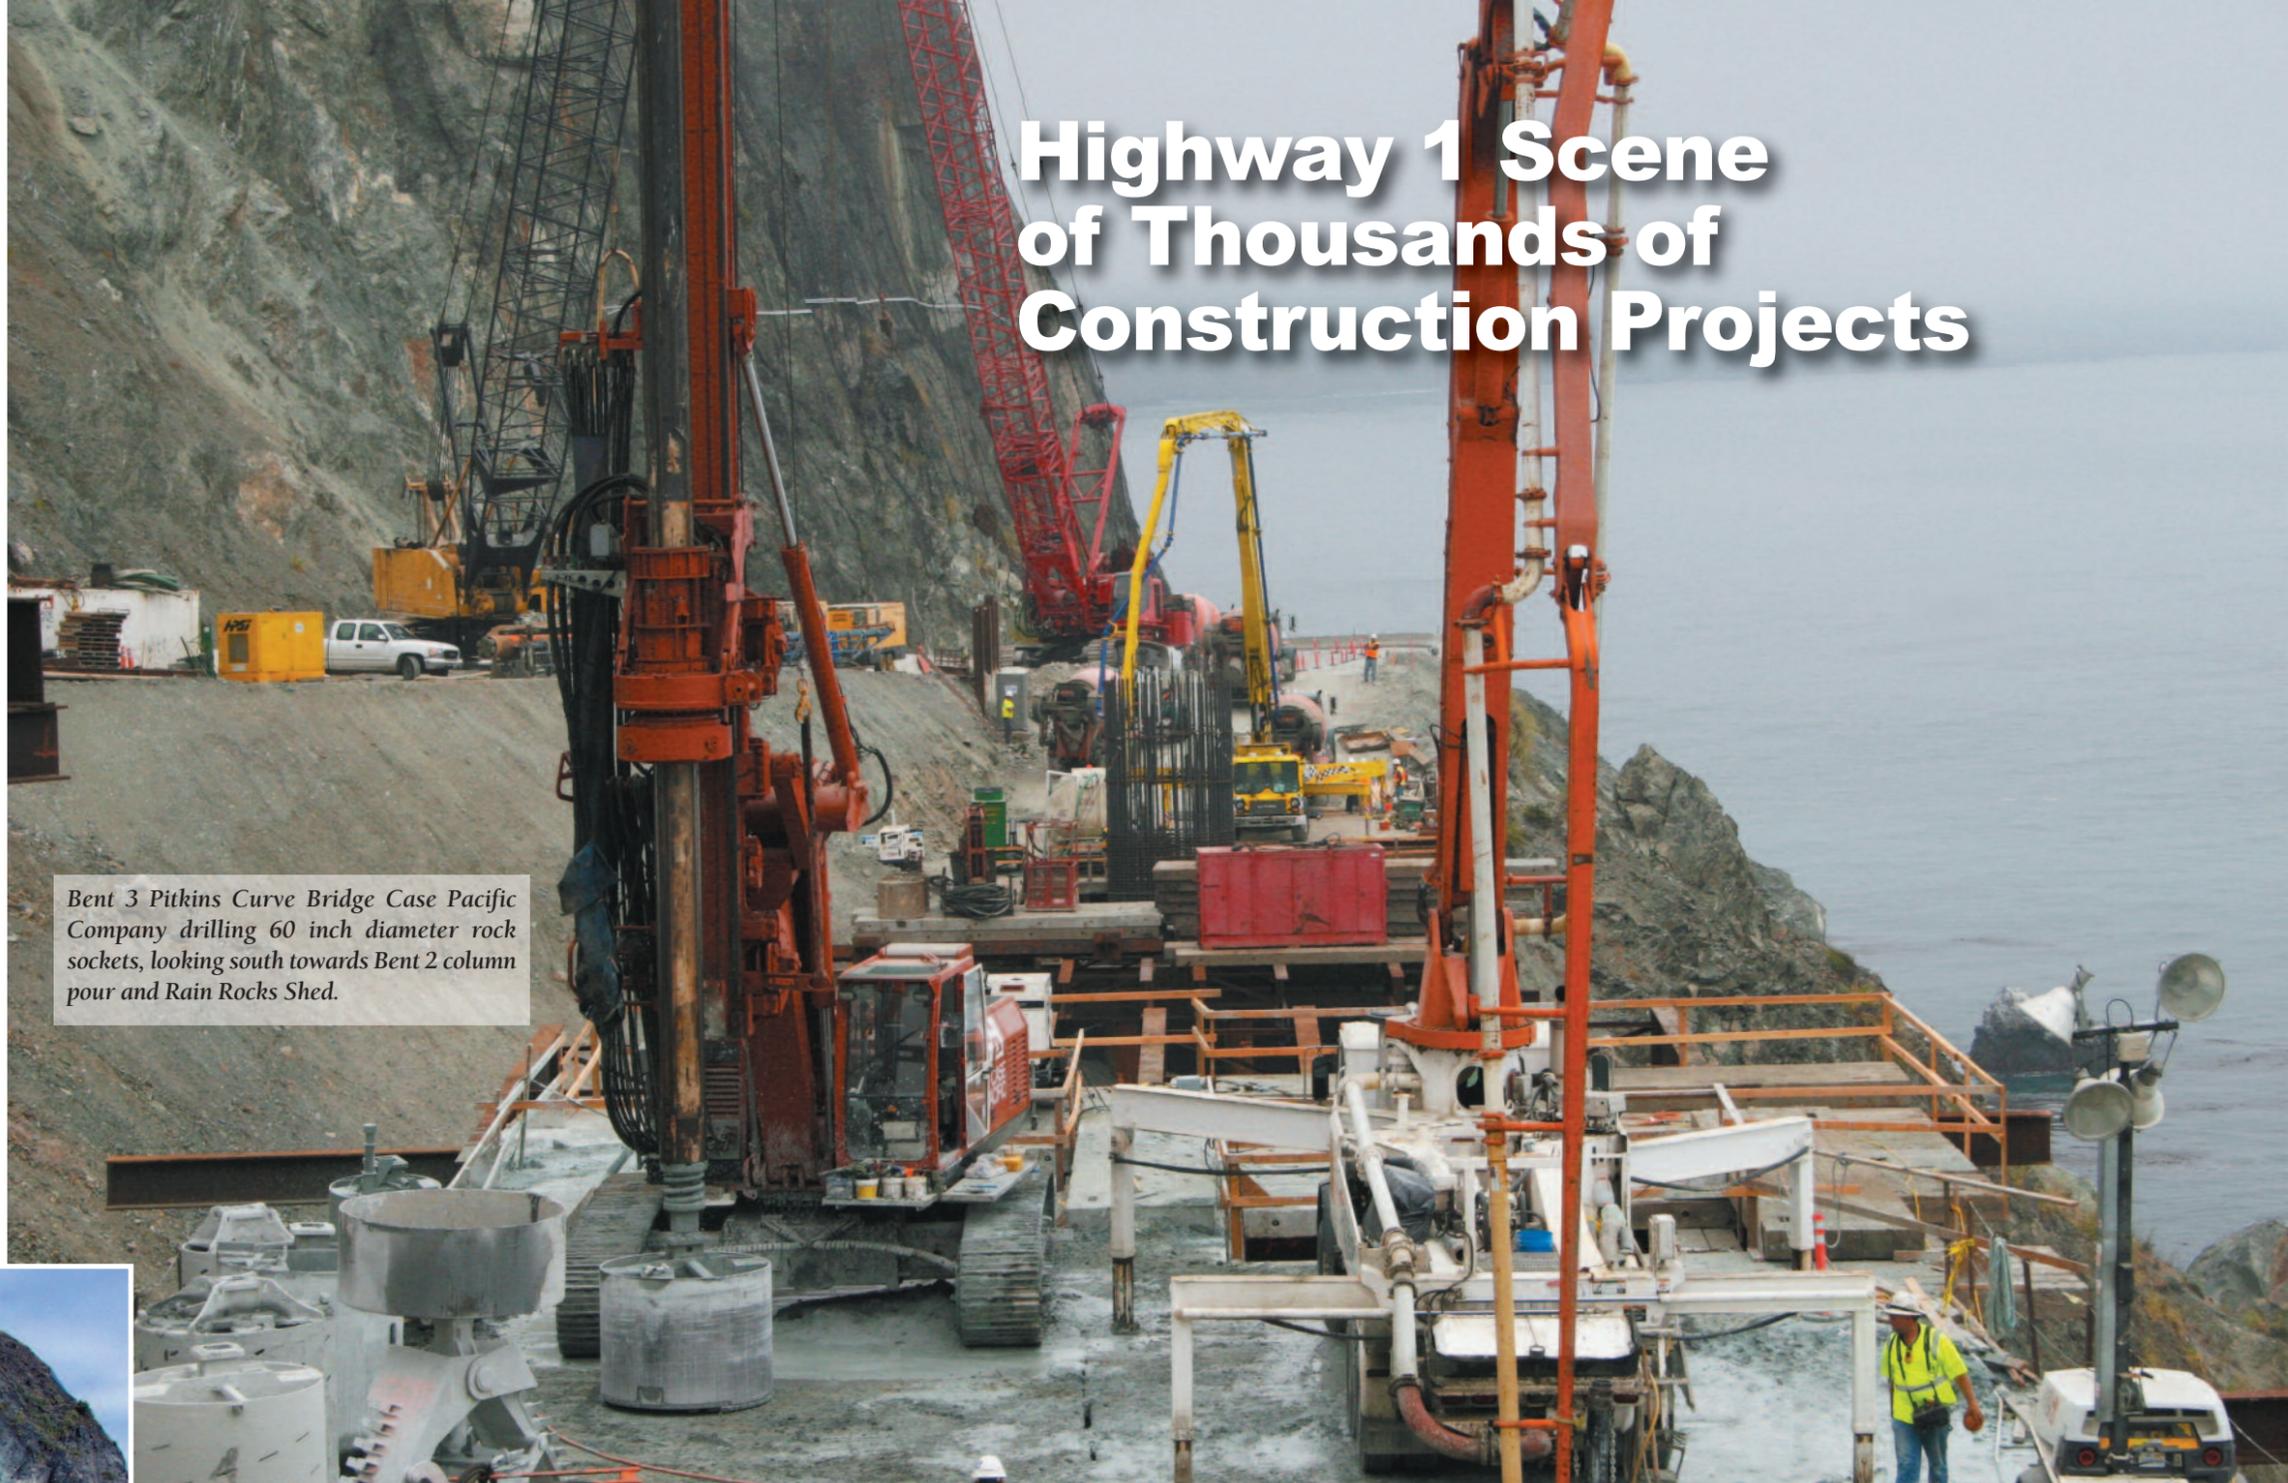
Bent 3 Pitkins Curve Bridge Case Pacific Company drilling 60 inch diameter rock sockets, looking south towards Bent 2 column pour and Rain Rocks Shed.

- Two piles at each abutment – 60 inch diameter x 40 foot deep rock sockets
- Bent 2 – Four each 60 inch diameter x 50 foot deep rock sockets with 18.50 foot deep 66 inch permanent casings
- Bent 3 – Four each 60 inch diameter x 60 foot deep rock sockets with 35.25 foot deep 66 inch permanent casings

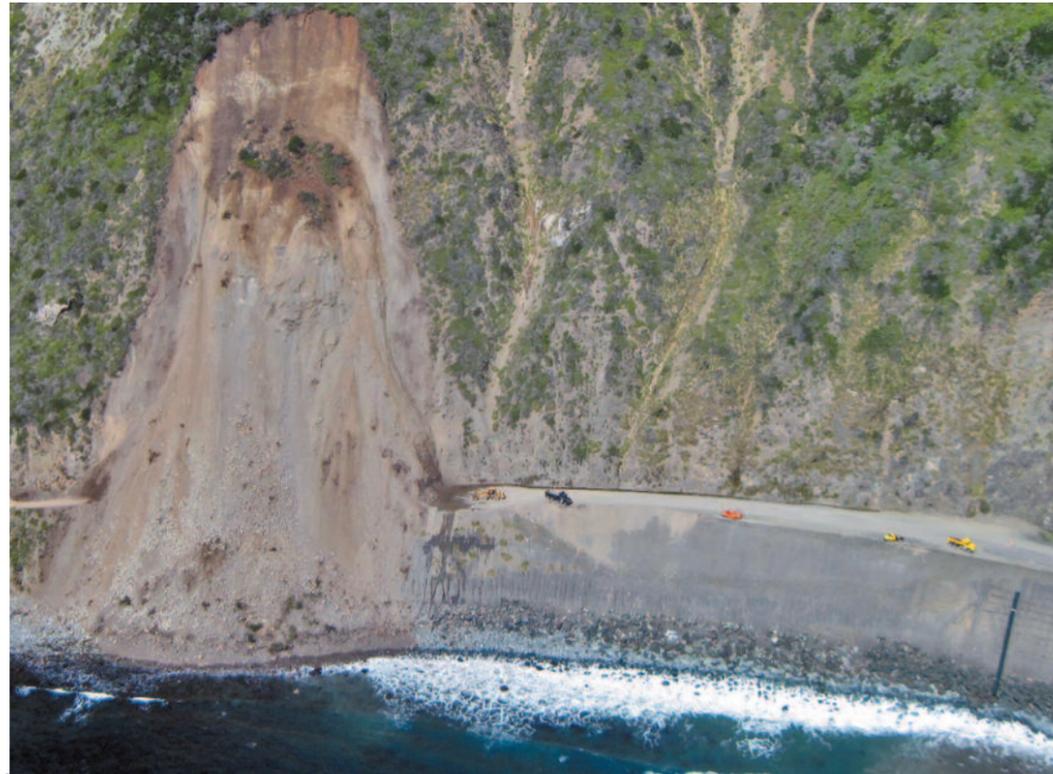
Massive landslide blocked Highway 1 fifteen miles south of the project for a couple of months.

During the last few months of work a massive landslide occurred 15 miles south of the project. This completely blocked the highway for months. During that time no oversized deliveries and no equipment could be moved to and from the project. To get to the site field personnel had to drive on a windy dirt road over the Santa Lucia Mountain Range, thus adding a treacherous two hours to the trip.

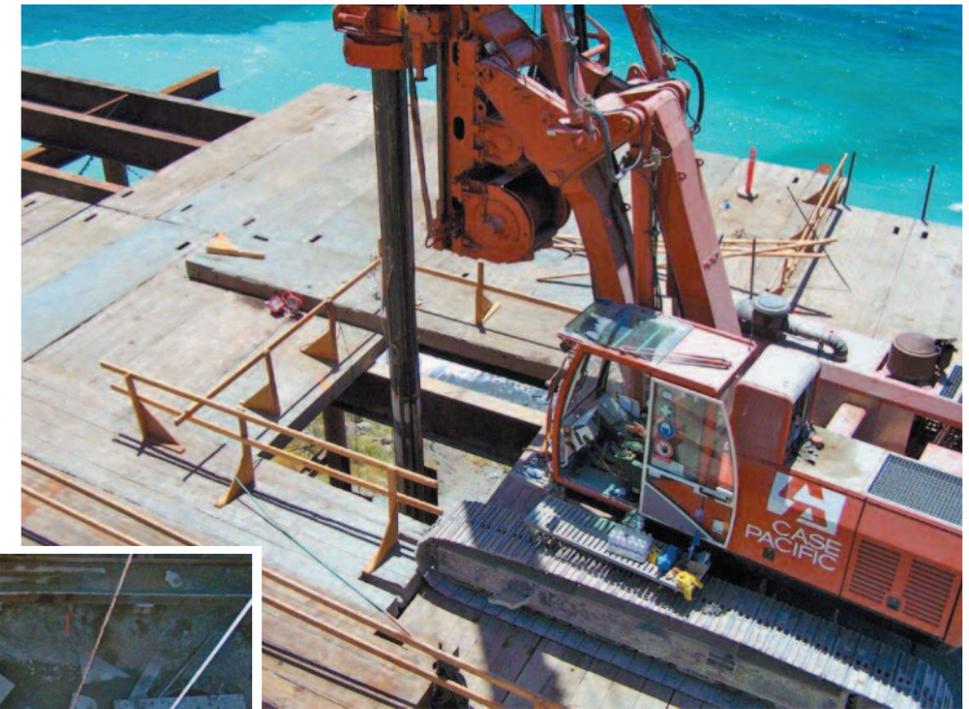
Bauer BG 20 on trestle working platform Bent 3.

CP had two drill rigs onsite for the majority of the job. These included a Delmag RH26 and a Bauer BG 20* which drilled on average 16 hours per day. CP personnel included **Brandon Christensen, Robert Tanguileg and Randy Virdell** as onsite Superintendents and **Will Gehrke** as Project Manager. All of the foundation work was performed with two shifts working around the clock. The CIDH Concrete Pilings were completed beginning in May of 2010 and through June of 2011.

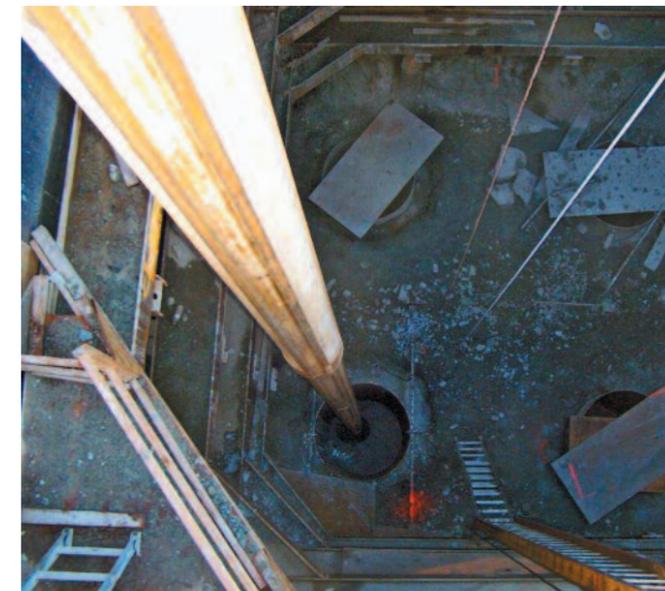
Looking down the cofferdam from the bent working platform at Bent 3.

Once getting equipment to the jobsite, Golden State Bridge (GSB) and CP had to figure out how to access the Bent piles for the bridge as well as all of the complex logistics of the project. GSB designed and installed a trestle bridge on each side to function as a working platform for the CIDH installation. They would later use this as the platform for their false work supports. GSB used a Symmetrix 24 inch SE 610 ring system with an Atlas Copco* Secoroc QL 200 down-the-hole-hammer to install the pipe pile to support the working platform. In order to provide CP with a safe working area at pile cut-off elevation a cofferdam was installed to the bottom of the bent pile caps.

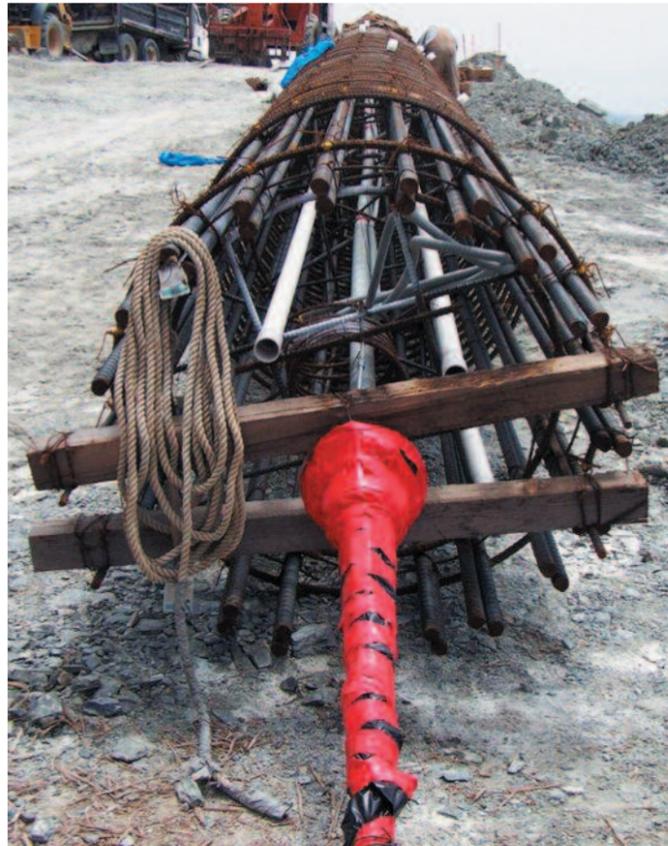
Rebar cage for the Bent piles at Pitkins Curve Bridge showing the congestion and tiedown anchor.

The dry method of concrete placement was a crucial element of the CIDH installation due to the congested rebar cages. If concrete had to be placed under wet methods, thus requiring Gamma Gamma testing, it would have added an additional degree of difficulty in construction. The rebar cages for the Bents at Pitkins Curve Bridge included installing a tiedown anchor down the center. It was then stressed to a load and locked-off to the pile cap under tension. Given these conditions, the wet method of concrete placement was nearly impossible to imagine. With the congested rebar in mind, CP Project Manager Will Gehrke, along with Mike Chernetsky of concrete ready-mix supplier Graniterock, performed extensive testing on the CIDH concrete mix. This step was taken in order to ensure that the flowability of the concrete would perform as needed.

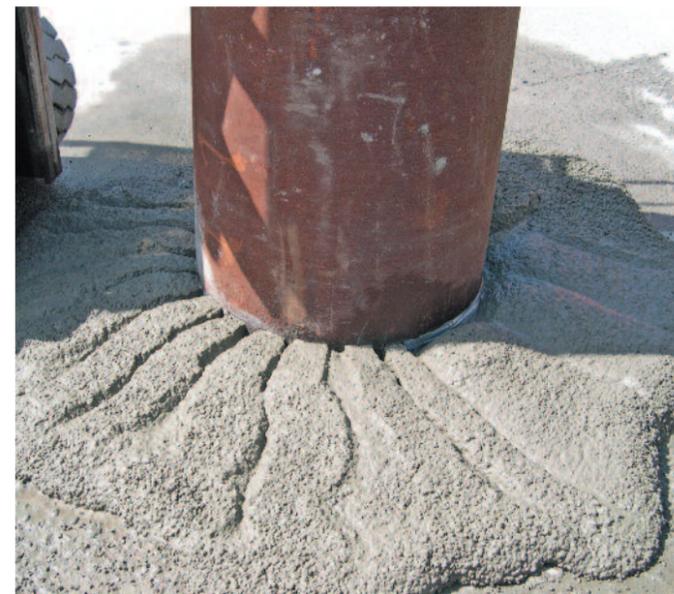
Concrete flowability testing apparatus used to test the mix.

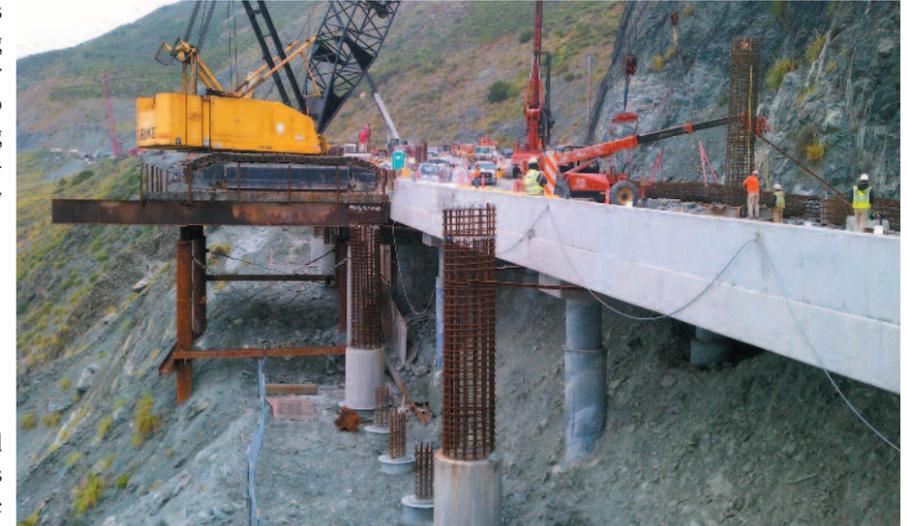
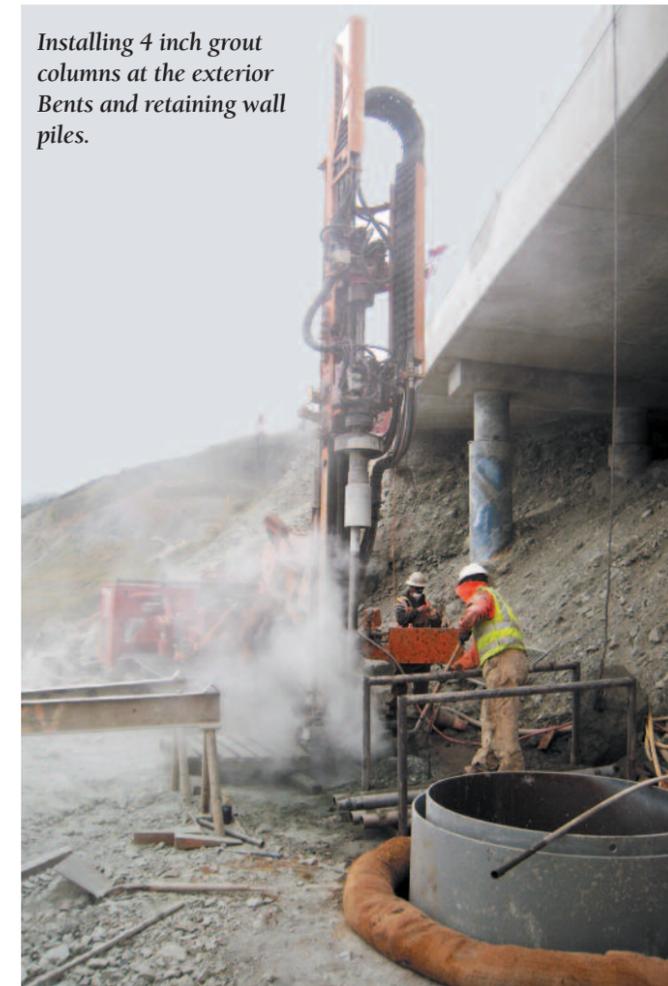
Installing 4 inch grout columns at the exterior Bents and retaining wall piles.

The interior Bents and retaining walls piles of the Rock Shed were installed in solid rock ranging in hardness from moderately hard to very hard rock. CP installed the casings and rock sockets with core barrels and rock augers, with little-to-no slide debris, caving conditions and or water intrusion. However, within the slide debris on top of the bedrock, the exterior Bents and retaining wall piles encountered excessive caving conditions. The solution was to install grout columns around the circumference of each shaft. For this CP used a 4 inch down-the-hole-hammer attached to an Interoc Anchor Drill model AN 109B*. The grout column held the caving material and the permanent casing were installed in a dry open shaft. The Rain Rock Shed piles were installed using the dry method of concrete placement.
